**An Investigation of Web Stresses
in Reinforced Concrete Beams**

WILLIAM IVERSON HARGIS, JR.

THESIS

IN THEORETICAL AND APPLIED MECHANICS

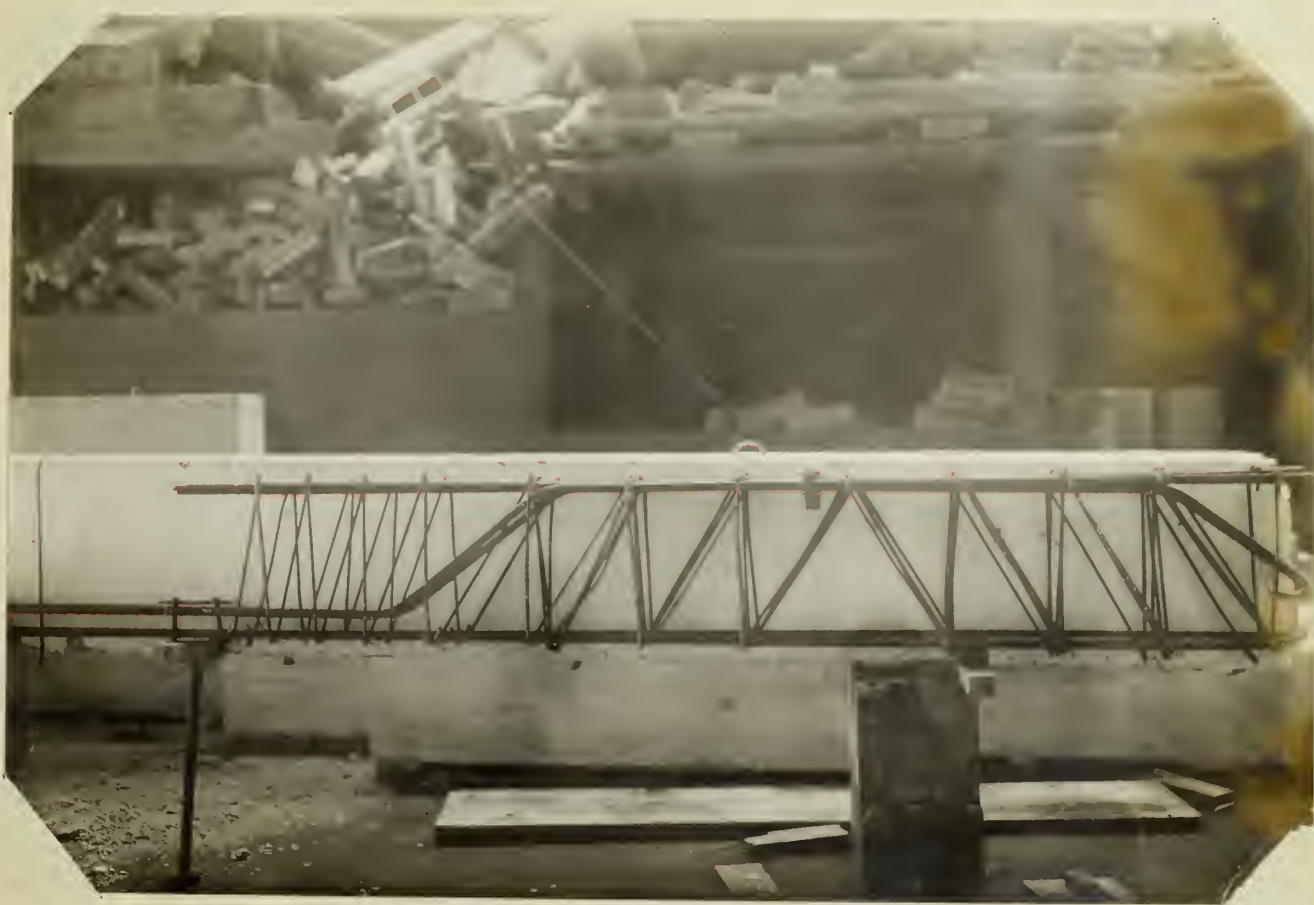
VIEW OF CORRUGATED BAR CO'S UNIT FRAME WITH ONE OF THE BEAMS
AS A BACK-GROUND

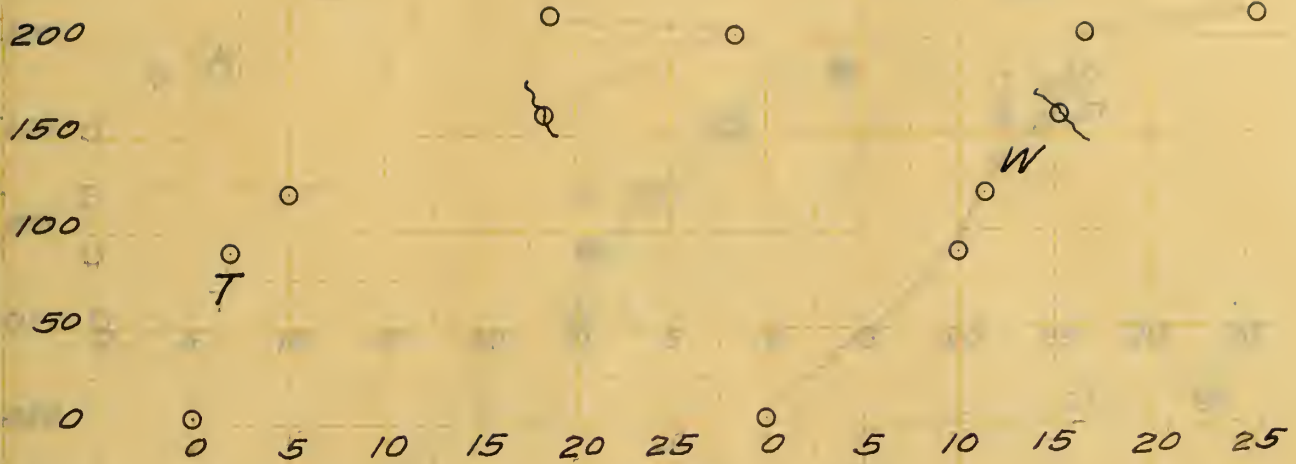
373.2

Q Passed yield point

Diagrams.—Shear — stress diagrams will be found on pages 70 to 84.. The values of the average unit shear in pounds per sq. in., are used for the ordinates and the unit stresses for abscissas. The letters refer to the gauge length, and a wavy line across a plotted point indicates the time at which a crack was observed to open across the gauge length. The moment — stress diagrams for some of the gauge lengths on longitudinal steel will be found on pages 85 to 93.. The moment has reference to the external bending moment at the section through the center of the gauge. Alongside of some of these plotted results are given the graphs representing the theoretical stresses on the steel, assuming beam action throughout, and using the straight line theory of stress distribution. On pages 94 to 100. are given the load-deformation diagrams for beams 374.1 and 375.1. The deformations were measured with the wire wound dials. The calibrations curves of the Berry instruments are given on pages 22 to 24. Three tests were made and two gauge lengths on the bar

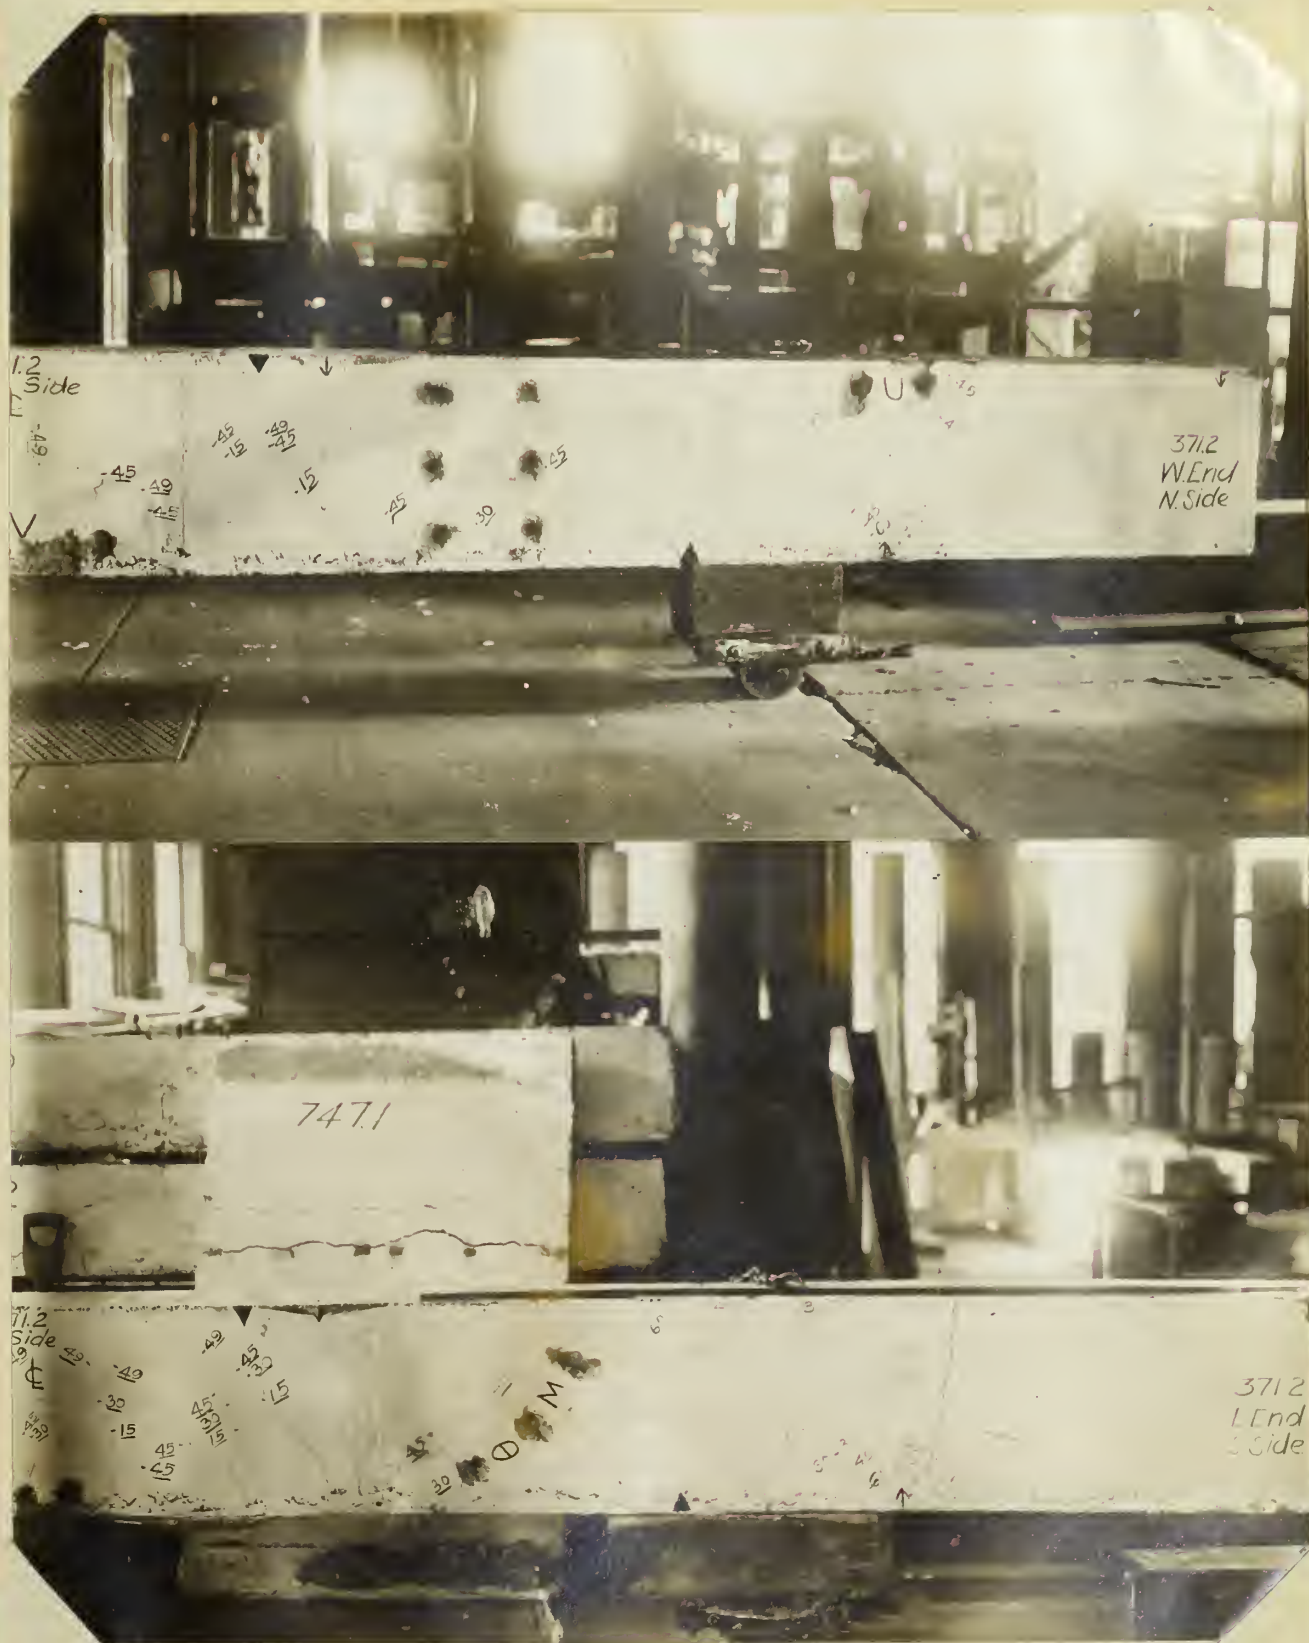
↓ Indicates the load and supports points during test as over-hanging beam.

▼ Indicates the load and support points during test as simple beam.

Photographs.—The photographs of the tested beams were taken after failure of the beams and after release of the loads. The figures on the beams indicate the loads at which the cracks opened up. In most cases the cracks were traced over with a lead pencil for the purpose of photographing. The notes accompanying the other photographs are self-explanatory.

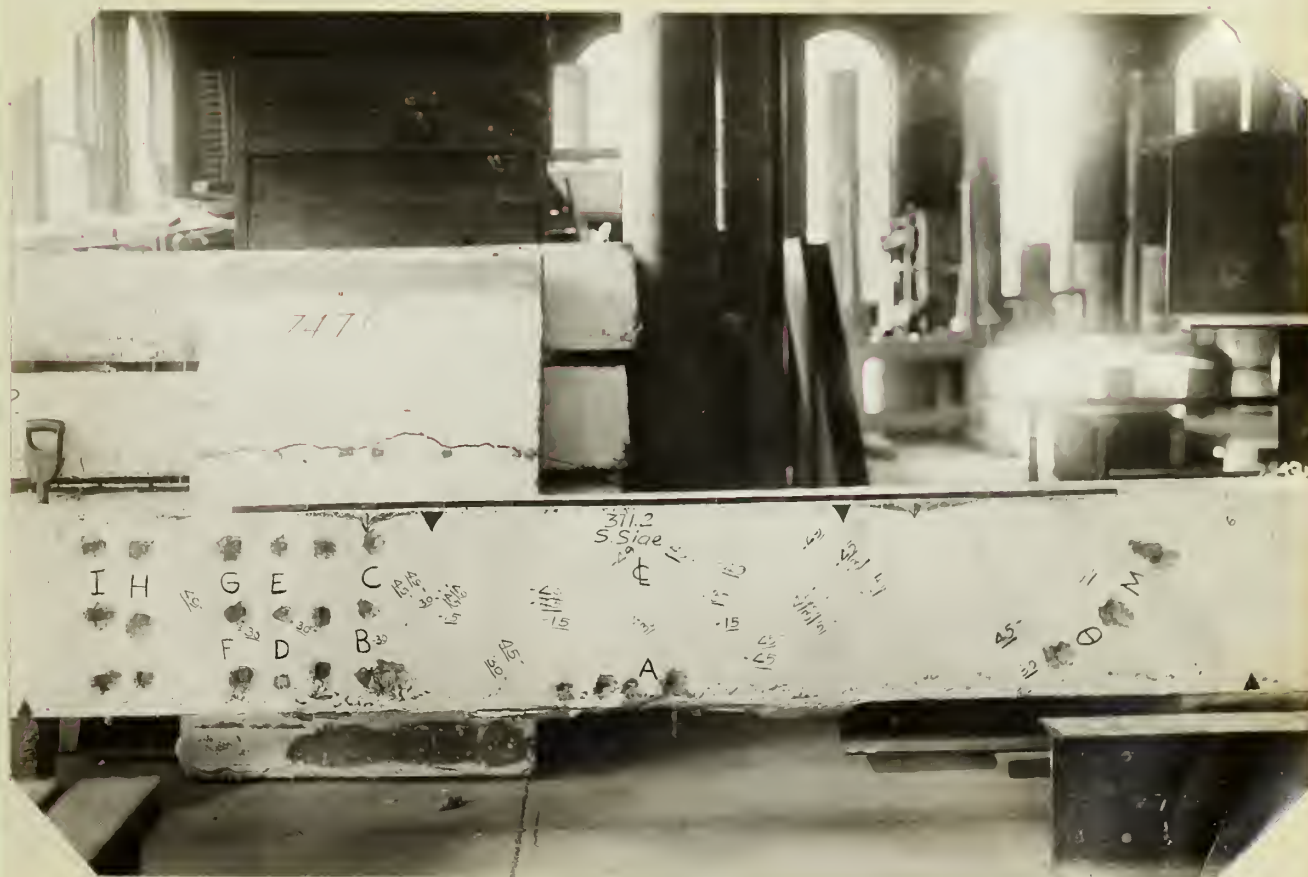
MIDDLE PORTION OF 371.2 AFTER TEST AS SIMPLE BEAM

Cracks indicated thus 30 opened during test as simple beam.

" " " 30 " " " " over-hanging beam.

65 400 lbs. After failure over the supports, the middle portion was tested as a simple beam as shown in Fig. 7 page 120. This portion carried a maximum load of 49 000 lbs. and failure was by tension in the horizontal steel in the center.
